'Namgis First Nation

Update of 2011 Phase I Environmental Site Assessment (ESA)

Phase 1 Environmental Site Assessment

Prepared by: BC Ecosphere Management Ltd., Vancouver, BC

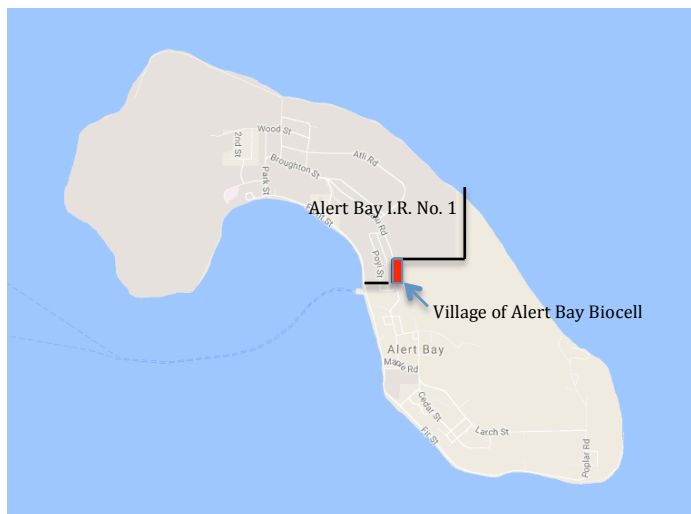
The Biocell depths and boundaries were clearly delineated during Site works with the Biocell liner functioning as a visual indicator of vertical and lateral extents. The Biocell is approximately 40m long from north to south, 20m wide from east to west and 1-1.5m deep with depths increasing slightly from east to west. The base liner of the Biocell appeared intact and in good condition with no visual signs of damage; the cover of the Biocell was not intact and was only visible along the boundaries of the Biocell.

Borehole soils observed along the entire perimeter of the Biocell were comprised of 'clean' coarse grain sands, gravels, some silt and cobble and had no characteristics of observable contamination based on both analytical data and field observations. Boreholes were drilled to a maximum depth of approximately 1.0 mbgs with no indication of groundwater at depth. Subsequent groundwater monitoring wells were installed at borehole locations and groundwater was not encountered at that time. Shallow surface water in the form of a perched table was found at the base of the Biocell atop the liner and is assumed surface water infiltration. Analytical results for this water indicate values approaching the CSR standard for LEPHs at 487 ug/L whereas the CSR criteria are 500 ug/L. The perched table is contained, but will be subject to further exposure to the contaminated soil within the Biocell and therefore we do not consider this solitary sample to be an accurate characterization of the water contained in the Biocell. It would be prudent for due diligence to assume that this perched water table is subject to contamination.

Vapour calculations indicated seventeen (17) samples exceed CSR Schedule 11 soil vapour criteria for Benzene, Xylene, Naphthalene and VPHs. This lends to the potential for human exposure in the immediate 100m vicinity of the Biocell and warrants the installation of a fenced closure with appropriate signage indicating that the Site is contaminated.

TerraWest concluded that the Site is contaminated in the media of soil and soil vapour and assumes the perched water table contained in the Biocell is subject to contamination. This conclusion warrants subsequent follow up remediation works and preparation of a Remediation Plan to bring the Site into
